CASE STUDY

Improved Turbine Durability Extends Inspection Intervals

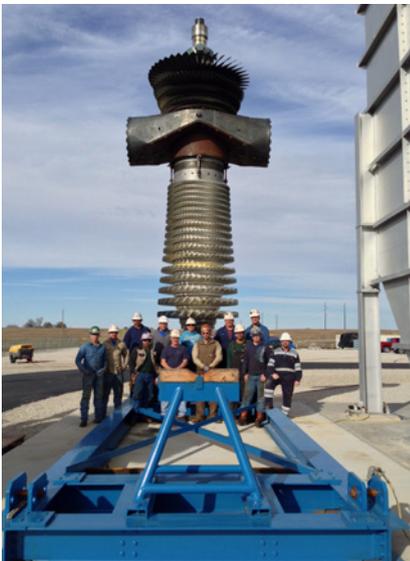
Field Services team getting ready to install a gas turbine rotor after overhaul

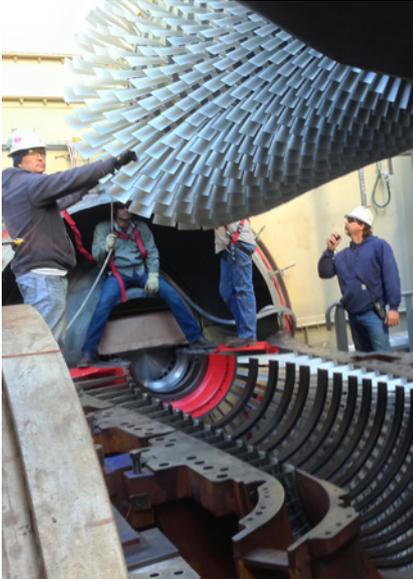
The experienced team at Sulzer proposed a range of modifications and enhancements to both the rotating and the stationary sections of the turbines

- The new compressor coatings greatly improved the corrosion resistance while reducing the reliance on the inlet dehumidification equipment.
- The flame tube F-ring was machined to allow an Inconel 82 overlay to be welded in place and machined to the required diameter.
- A full thermal barrier coating (TBC) was applied to the combustion section.
- Additional cooling holes were drilled in the flame tube to improve durability and minimize erosion and oxidation.

A ceramic TBC was applied to the bezel rings and segment plates, mixing elbows and inner casing, in order to increase the resistance to thermal distress in the hottest areas of the unit. In addition, a chromium carbide coating was applied to all of the mating surfaces of the combustion section to minimize wear as the parts expand and contract.
